JMS578固件分位更新 (适用3139U3、6139U3、7688U3、MD35U3)

JMS578_Firmware Update_ (For 3139U3、6139U3、7688U3、MD35U3)

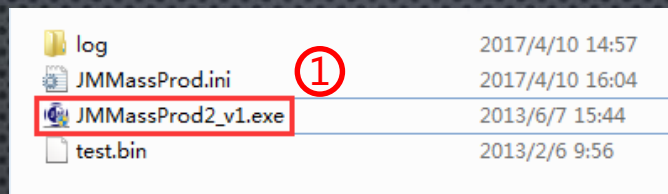
步骤一：打开“Tool”文件夹，运行“JMMassProd2_v1_16_14_25.exe”程序。

Step 1, Open the "Tool" folder and run the " JMMassProd2_v1_16_14_25.exe " program.

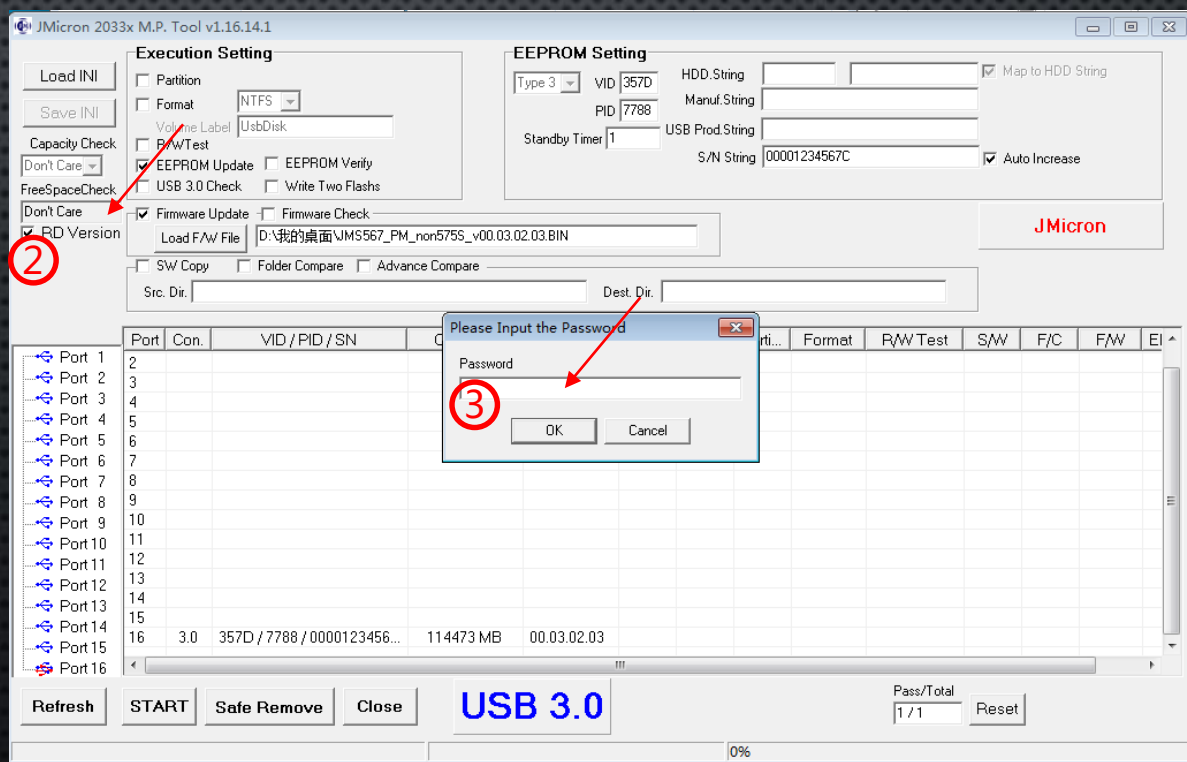
步骤二：勾选上“RD Version”。

Step 2, Check the "RD Version"

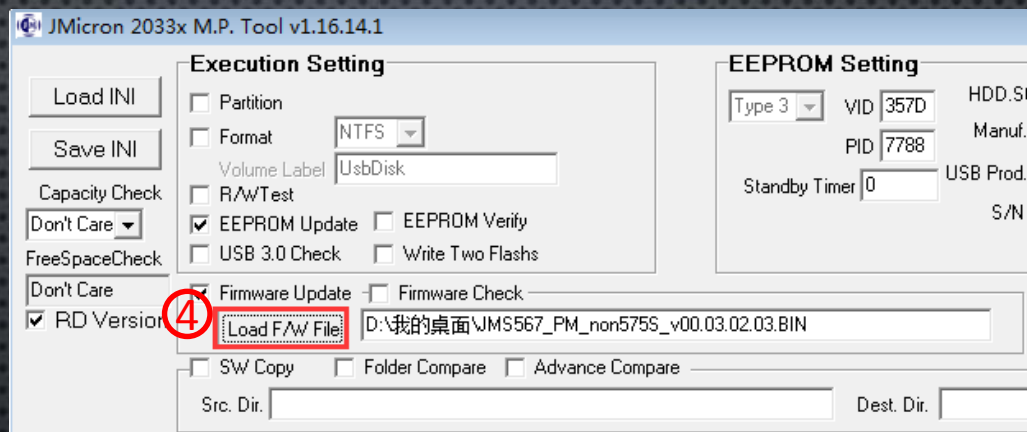
步骤四：点击 “Load F/W File” 加载固件。

Step 4, Click "Load F / W File" to load the firmware file.

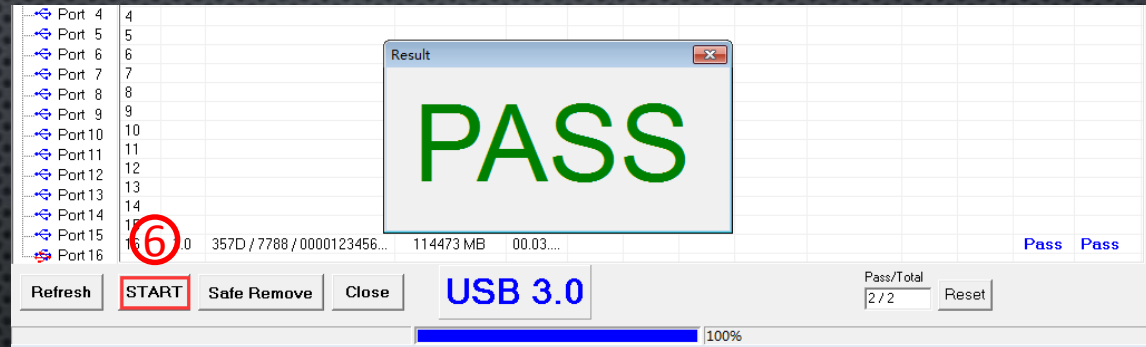
步骤六：点击“START”开始刷新固件，提示PASS，表示刷新固件成功。

Step 6,Click “START” to start refreshing the firmware, suggesting that PASS, that refresh the firmware success .
